THE PUZZLE OF THE CRASH OF FEDEX FLIGHT 1478: IMPLICATIONS FOR COLOUR VISION STANDARDS IN AVIATION

Arthur Pape,
 MBBS
 Boris Crassini,
 BA(Hons) PhD

Pape A, Crassini B. The puzzle of the crash of FedEx Flight 1478: Implications for colour vision standards in aviation. J Aust Soc Aerospace Med 2013;8:28-31

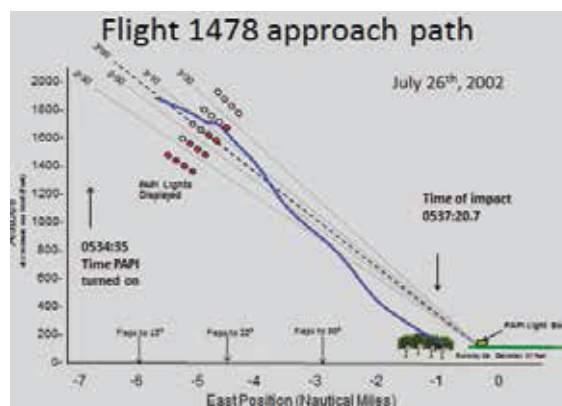
Figure 1.

On July 26, 2002, in pre-dawn darkness, FedEx Flight 1478 crashed into a state forest about a mile short of the threshold of Runway 9 at Tallahassee Airport in Florida, USA. The reconstructed flight profile of Flight 1478 (the blue line in Figure 1) is typical of a 'black hole' accident. These accidents involve pilots' misperception of their glideslope angle to a runway as higher than it actually is (see Gibb, Gray, & Scharff¹ for a comprehensive discussion of this topic). Because of this misperception, pilots descend too steeply and often impact the ground short of the runway, in what constitutes an 'undershoot accident'. The NTSB Report² into the crash indicates that Runway 9 at Tallahassee had a classification of moderate risk of 'black hole' accidents. However, the visual approach to Runway 9 was equipped with a precision approach path indicator (PAPI) device, the primary purpose of which is to prevent 'black hole' accidents by providing pilots with information about their glideslope angle during approach to landing.

The five vertical wedge-shaped sectors of airspace in which these five colour-coded patterns of PAPI lights are theoretically visible are shown in Figure 1, with the apex of each wedge-shaped sector at the location of the Runway 9 PAPI device. Overlaid on these five sectors of airspace is the vertical flight profile of FedEx Flight 1478 during final approach. Figure 1 therefore shows the different patterns of PAPI lights supposedly visible to the crew of Flight 1478 during its approach to land.

descent in order to intercept the 'proper' approach angle of 3°. Similarly, observation of a pattern of four red PAPI lights should result in the pilot and crew aborting the approach, and initiating a 'go round'. It is clear from the flight profile shown in Figure 1 that although during the final three minutes of Flight 1478, a pattern of four red PAPI lights was supposedly visible to the crew, their actions were more consistent with perception of a pattern of four white PAPI lights ('lower the nose of the aircraft') than perception of four red PAPI lights ('go round').

The blue line shows the reconstructed flight profile of Flight 1478 over about the final six nautical miles and about final three minutes before it crashed into trees short of Runway 9. Also shown are the five wedge-shaped sectors of vertical airspace radiating from the Runway 9 PAPI device, and the different patterns of white and red PAPI lights supposedly visible in each sector, corresponding with the final approach of Flight 1478. The distances to run at which the various stages of flaps were set are shown on the horizontal axis. (Adapted from NTSB²).

As already noted, the actions of the crew of Flight 1478 as reflected in Figure 1 in the reconstructed flight profile of the final stages of Flight 1478 are *not consistent with* the crew seeing four red PAPI lights¹. However, these actions *are* consistent with the crew seeing four *white* PAPI lights. This begs the question: 'Can red PAPI lights look like, and therefore be confused with, white PAPI lights, and if so, under what conditions?' Two different answers to this question seem to be provided in the NTSB Report, and can be summarised as follows:
